STAMP-based analysis on the railway accident and accident spreading: Taking the China–Jiaoji railway accident for example

Min Ouyang^{a,b}, Liu Hong^{a,*}, Ming-Hui Yu^a, Qi Fei^a

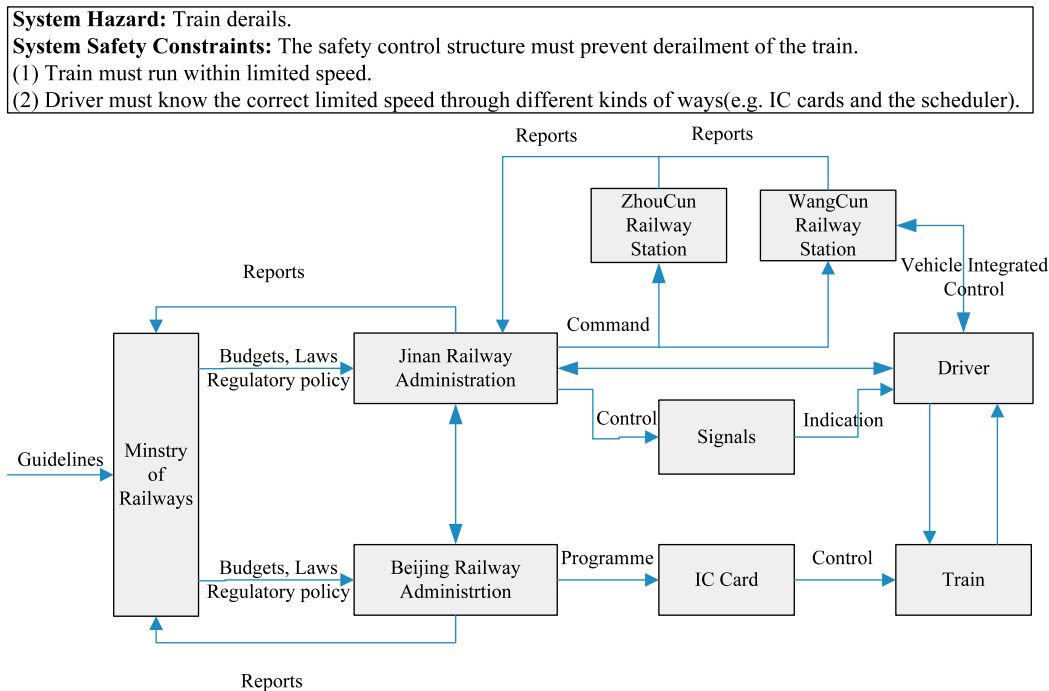
Fig. 4. The overall train operation control structure in the China–Jijiao railway accident and the safety-related requirements and constraints for each controller.

According to the procedure of STAMP-based accident analysis, the first step is to identify the system hazards, the system safety constraints, and the hierarchical control structure in place to enforce the constraints. The system hazard related to the China–Jiaoji railway accident is derailment of the train. This hazard needs the following system safety constraint: (1) Trains must run within limited speed. (2) Driver must know the correct limited speed through different kinds of ways (e.g. IC cards and the scheduler in duty). Then, according to the accident process introduced in Section 3.1, the hierarchical control structure to enforce above two constraints is shown in Fig. 4, and the safety-related requirements and constraints for each controller are also listed below in Fig. 4.

Each controller in the control structure plays a role in enforcing some safety constraints to prevent initial collapse. The Chinese government is responsible for establishing guidelines and legislations to ensure railway safety. Guidelines are provided to the ministry of railways, but responsibilities for railways safety are primarily delegated to each railway bureau. The ministry of railways is responsible for regulating and overseeing the safe operation of railway systems. They do this by passing laws and adopting government policies and by providing budgets to each railway bureau, such as Jinan railway bureau and Beijing railway bureau. The railway bureaux (Jinan railway bureau, Beijing railway

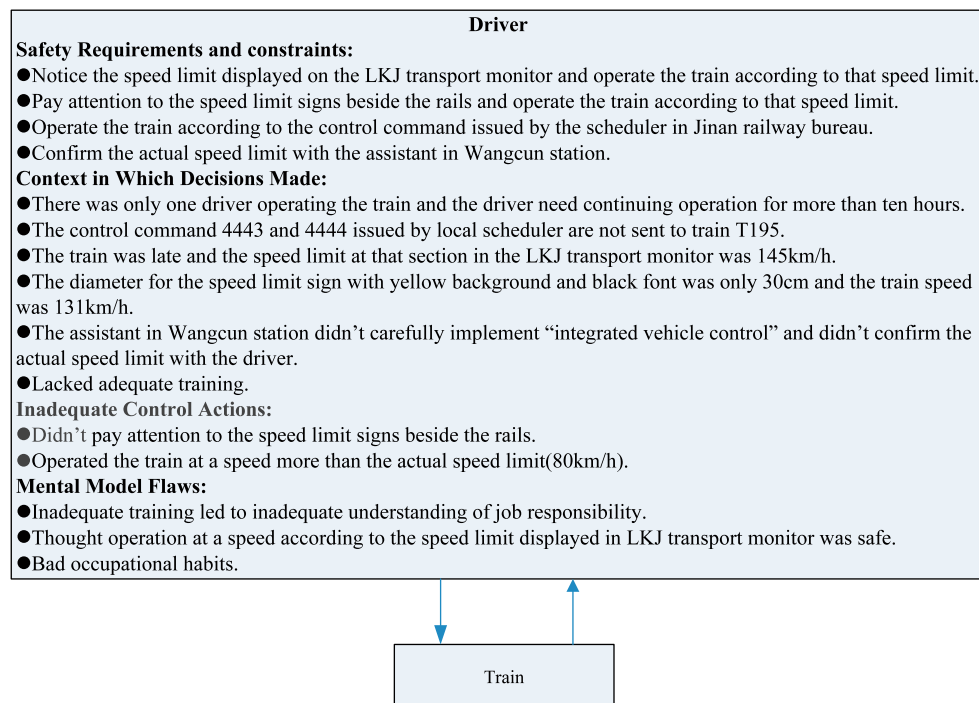
Fig. 5. The role of the train T195’s driver in the accident.

Most hazard analysis techniques and accident investigations consider the immediate operators of the system. Fig. 5 shows the results of a STAMP analysis of the flaws by train T195’s driver. The safety requirements and constraints on the driver were that they must notice the speed limit displayed on the LKJ transport monitor and must operate the train according to that limit. However, the Beijing railway bureau received the control command requiring to cancel the temporary speed limit (80 km/h, contained in the control command 4240 issued in March) in that section before receiving the file 154 (changing the speed limit to be long-term limit), so the speed limit on train T195 in that section displayed on the LKJ transport monitor was changed to be 145 km/h.

Although the problem (inconsistency between the speed limit on the LKJ transport monitor and the actual speed limit) had been found and the Jinan railway bureau issued new control command 4443 and 4444 requiring drivers to limit the speed to 80 km/h in that section, this new control command was not sent to train

T195. When train T195 approached to Wangcun railway station, according to the regulations, the staffs in that station should carefully implement the “integrated vehicle control” and confirm the actual speed limit with the driver. But due to their negligence, the driver passed that station without knowing the actual speed limit.

In addition, the speed limit signs beside the rail show the actual speed limit, but the driver did not pay attention to that. There may be several reasons for this mistake. First, due to busy operation task, most train drivers in china should work for more than 200 h every month, even over 300 h, which cause their tiredness. Moreover, there was only one driver operating at 4 o'clock in the morning (the time of the accident) that is the most tiredness time for human bodies. Second, it may be as result of his bad occupational habit. To ensure the train operated on schedule (If the train is late, the driver will take responsibility for that and his salary will be cut), drivers have to operate the train at a speed approached to the speed limit. Especially in this accident, the train was late while local scheduler in duty also asked him to do rush on the way, so the driver paid more attention on the LKJ transport monitor and operated the train at the speed approaching to the speed limit. Third, the diameter for the speed limit signs with yellow background and black font was only 30 cm while the driver operated the train at a speed 131 km/h, it is difficult to see clearly the signs. Forth, it is the most important thing for the driver to pay much attention to all speed limit signs besides the rails, but the driver did not take his responsibility and ignored its importance, which was also due to inadequate training.

Together, the driver did not know the actual speed limit while the train was late, and then the driver thought operation at a high speed according to the LKJ transport monitor was safe, which caused the accident happened.

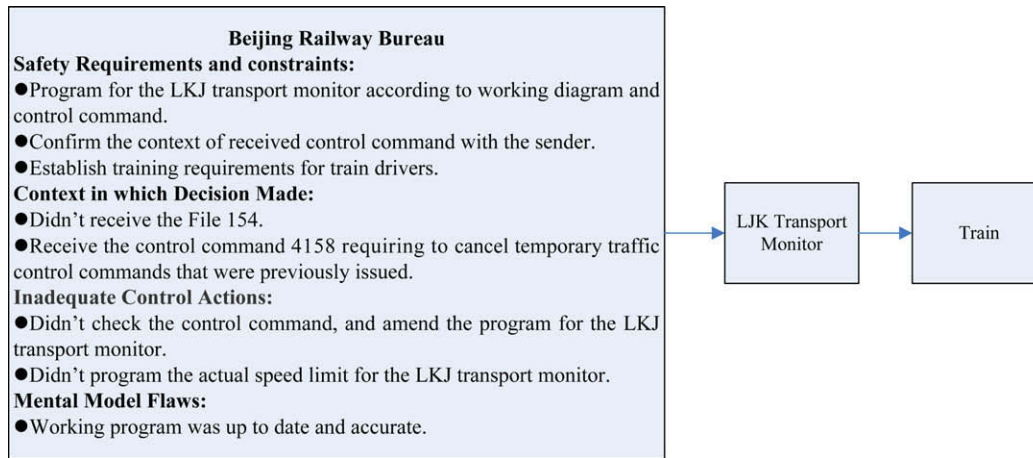
Fig. 6. The role of the Beijing railway station in the accident.

Fig. 6 summarizes the role of Beijing Railway Bureau in the accident. The Beijing Railway Bureau has primary responsibility for programming for the LKJ transport monitor according to the

working diagram and control commands, confirming the context of received files or control command with the sender, and establishing training requirements for train drivers. However, they received the control command 4158 requiring to cancel the temporary speed limit in that section before receiving the file 154, so the speed limit on train T195 in that section had been programmed to be 145 km/h in the LJK transport monitor, which was not the actual speed limit 80 km/h. But in fact, the control command said: "According to the file 154 used for adjusting the working diagram, from the time 0:00 on April 28, 2008, cancel the control command 4240 issued on March 23, cancel the control command..." This command had referred to the file 154, Beijing Railway bureau did not check the file 154 and then amended the program for the LJK transport monitor so that the speed limit in that section returned to be 145 km/h, which was one reason to cause the accident.

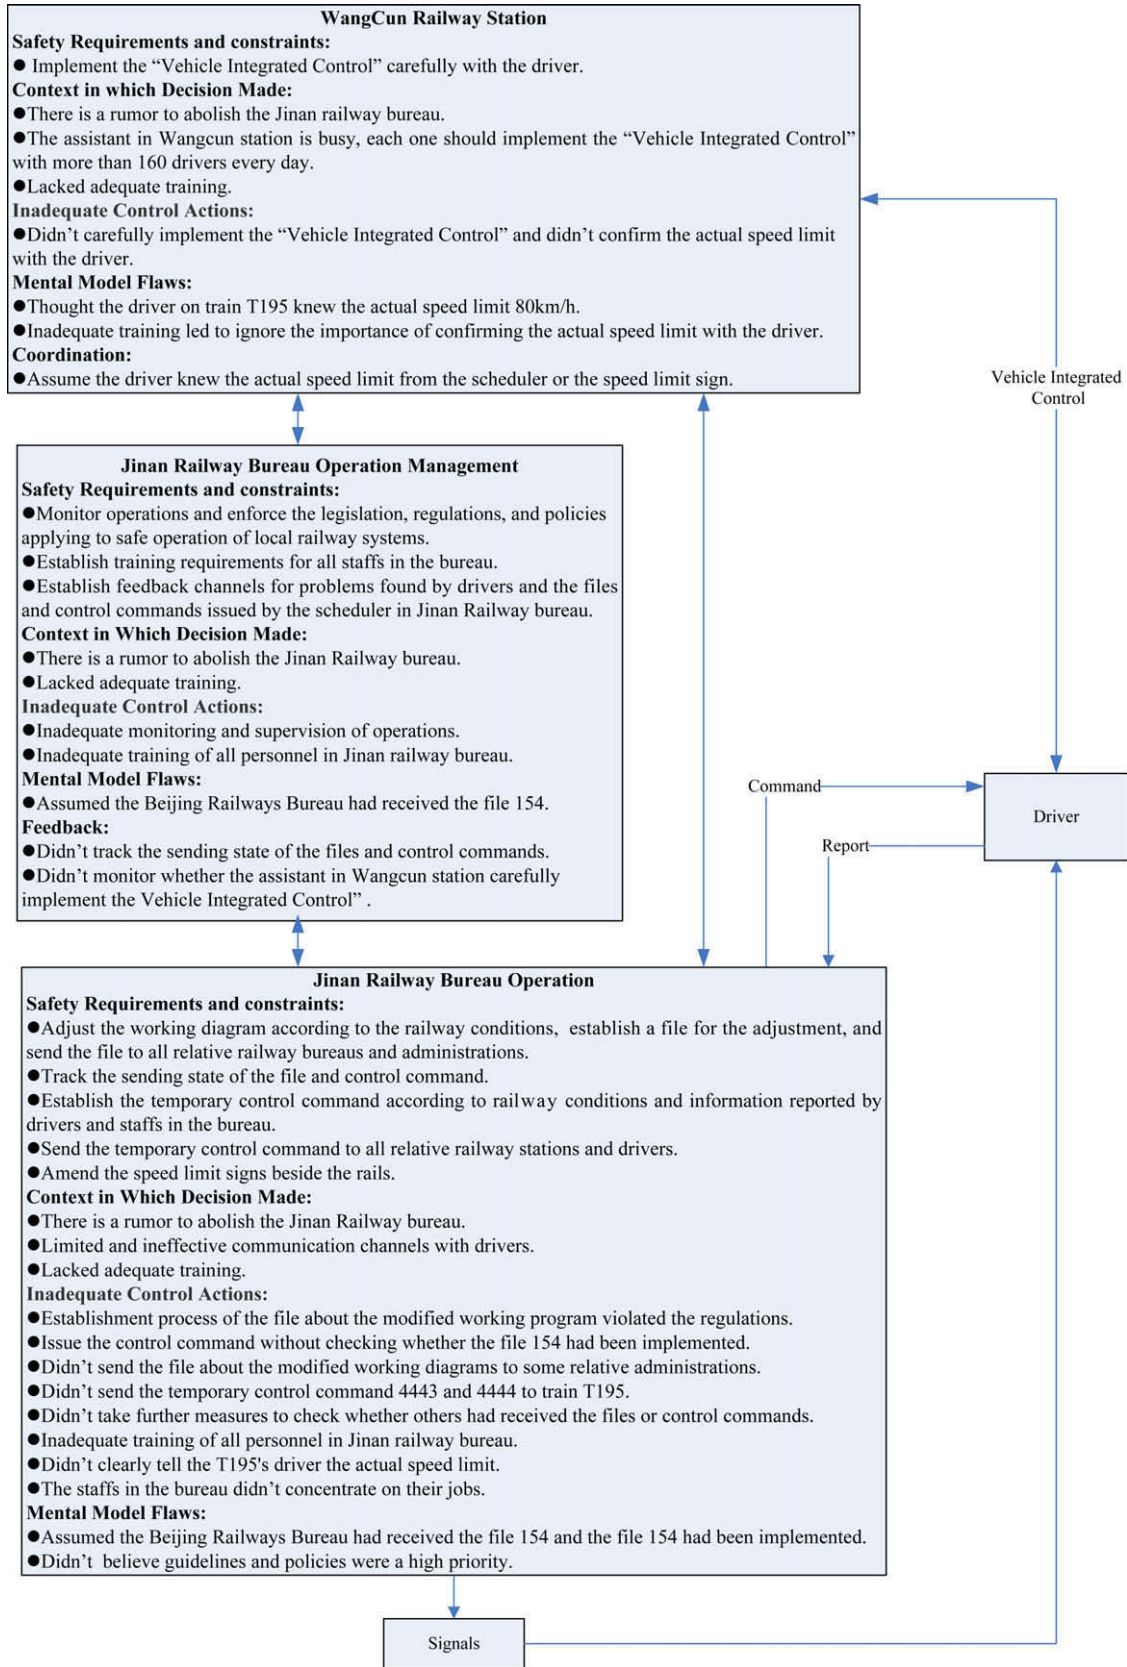
Fig. 7. The role of the Jinan railway station and Wangcun railway station in the accident.

The accident happened in the place near the Wangcun railway station dominated by the Jinan railway bureau. In this section, the role of Jinan railway bureau and Wangcun railway station in the accident will be analyzed, as can be seen in the Fig. 7. Wangcun railway station has responsibility for carefully implementing the "Vehicle Integrated Control" with the driver. However, when train T195 approached to that station, the assistant did not confirm the actual speed limit with the driver. According to the investigation, there may be several reasons for this mistake. First, due to high traffic density, there were more than 160 vehicles passing through the Wangcun station per day. So the assistant had to implement the "Vehicle Integrated Control" with a driver every 9 min, even 2 or 3 min in the rush hour. This high workload increased the probability that the assistant did not carefully implement the "Vehicle Integrated Control" with the driver due to some subjective guess. Second, there was a rumor to abolish the Jinan railway bureau, some of which had been rectified. It made the people affiliated to Jinan railway bureau feel nervous and could not concentrate on their job. Third, due to inadequate training, the assistant ignored the importance of confirming the actual speed limit with the driver.

The assistant in Wangcun railway station did not intentionally violate the rules and put the train T195 at risk. Before train T195 approached to the station, train T25 with the same vehicle type had passed that section safely, and then the assistant thought train T195 should also have received the control command from the scheduler in duty in Jinan railway bureau and would be safe to pass that section.

To analyze the role of Jinan railway bureau in the accident, the discussion will be performed from two aspects. One is the Jinan railway bureau operation while the other is the management. For the former, they have primary responsibility for adjusting the working diagram according to the railway conditions, establishing a file for the adjustment and sending the file to all relative railway bureaus and administrations. However, the staff in the bureau ignored the high priority of abiding by the guidelines and regulations so that establishment process of the file 154 violated the regulation. According to the regulation, they must send the file 154 to the ministry of railways for confirmation and then amend the data for LJK transport monitor. But they did not do like that and they also did not check whether others had received that file so that the long-term speed limit in the accident section had not been amended correctly. At the same time, the scheduler in Jinan railway bureau thought the speed limit in that section had been changed to long-term limit 80 km/h, and then another control command to cancel the temporary speed limit in that section had been issued, which finally caused the speed limit in LJK transport monitor on train T195 was changed to 145 km/h. Although the problem (inconsistency between the speed limit on the LJK transport monitor and the actual speed limit) was found through the feedback by other drivers and new control command 4443 and 4444 requiring the speed limit to 80 km/h at that section was issued, this new command was forgotten to send to train T195. In addition, the scheduler in duty contacted with the train T195's driver through wireless phone, he did not clearly express his idea such that the driver still did not know the actual speed limit when the communication was over. These mistakes may be due to the inadequate training or the rumor to abolish the Jinan railway station, causing the staff in the bureau felt nervous and could not concentrate on their jobs. In addition, contacting with the driver only through wireless phones was not very effective, due to the man-made mistake, the wireless phones sometimes could not clearly express the idea, so more effective means could have been employed.

For the latter—Jinan railway bureau operation management, they have primary responsibility for monitoring operations and enforcing the legislation, regulations, and policies applying to safe operation of local railway stations, establishing training requirements for all staffs in the bureau, establishing feedback channels for problems found by drivers and the files and control commands issued by the scheduler in Jinan railway bureau. But from the above discussion, the disordered management indicated that they had inadequate monitoring and supervision of the operations, which may also be due to bad effect of the rumor. Moreover, the

Jinan railway bureau also did not perform adequate training to the personnel so that the staffs either violated the regulations or did

not know the regulations. In addition, lacked feedback channels were also one reason to cause the accident, i.e. the Jinan railway

bureau did not track the sending state of the files and control commands, and they also did not monitor whether the assistant in Wangcun railway station carefully implement the “Vehicle Integrated Control”.

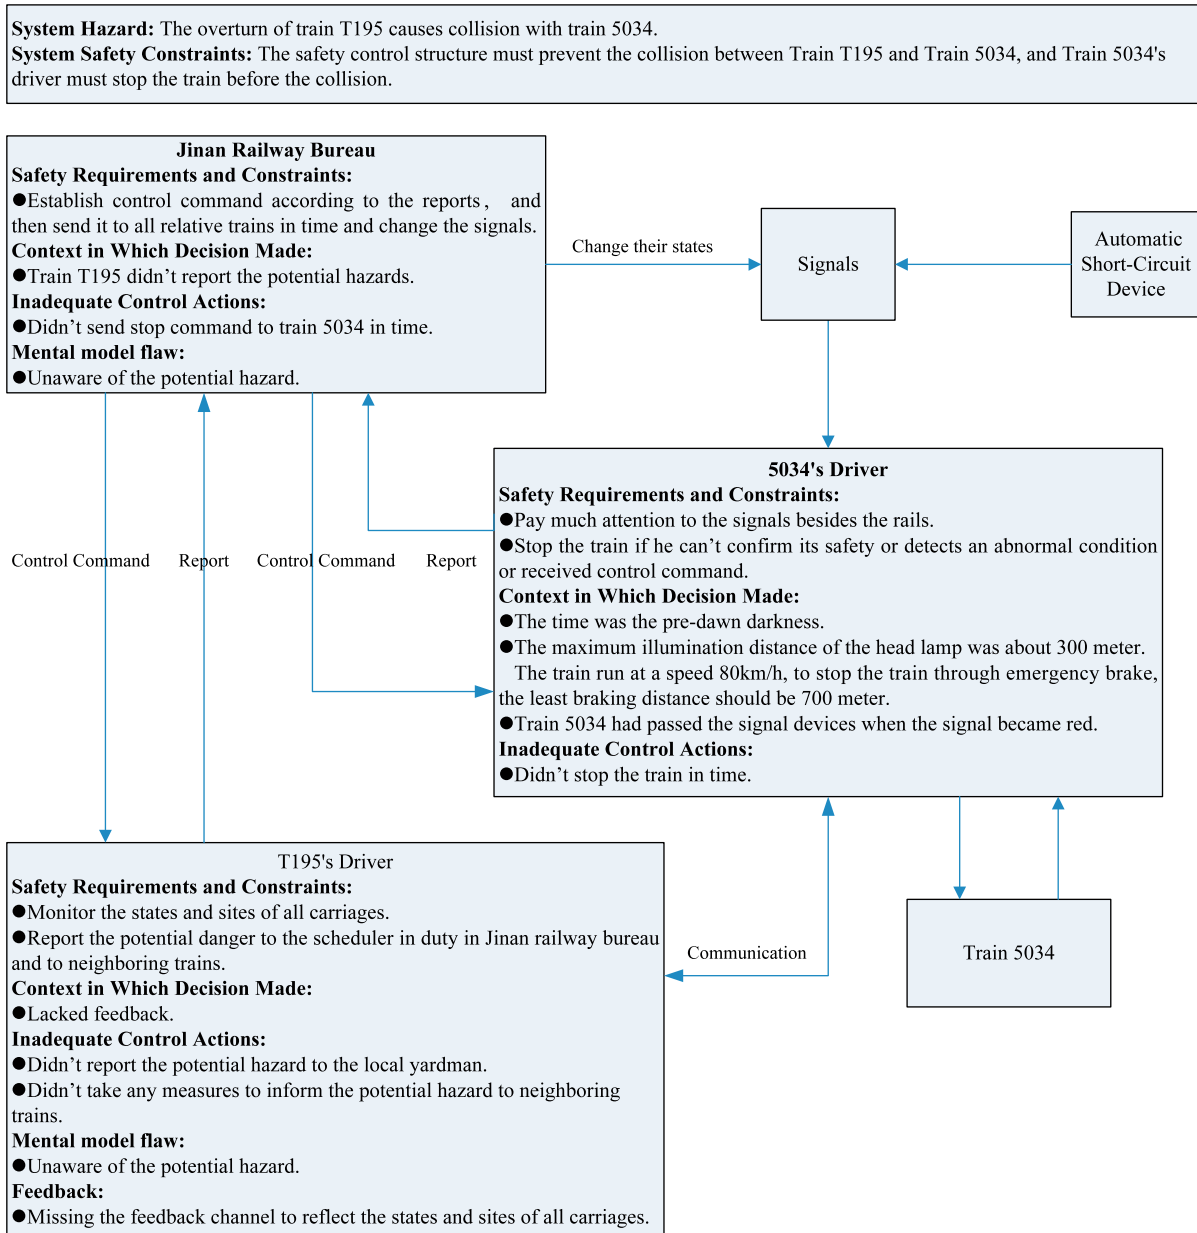
Fig. 9. The system hazards, the system safety constraints, the control structure and system component safety constraints in the second accident.

According to the procedure of STAMP-based accident analysis, the system hazards, the system safety constraints, the control structure and system component safety constraints have been shown in the Fig. 9. The system hazard related to the second accident was that the overturn of train T195 cause a collision with train 5034. This hazard leads to the following system safety constraints: the safety control structure must prevent the collision with train T195 and the train 5034's driver must stop the train before the collision.

For train T195's driver, he has the responsibility for monitoring the states and sites of all carriages and reporting the potential danger to the scheduler in duty in Jinan railway bureau and to neighboring trains. However, when train 195 derailed, due to lacked feedback to monitor the sites of all carriages, the driver did not know the train had toppled on the other rails and did not report the potential hazard to the local scheduler in duty and also did not take any measures to inform train 5034 on the other rails. Further, the Jinan railway bureau was also unaware of the potential hazard and they didn't send stop command to train 5034.

Although the automatic short-circuit device caused all signals in that zone became red, it is unfortunate that the train had entered that zone and the driver saw no signals. Because the braking system of train 5034 only had limited capability, the driver could not stop the train in time when he found the danger. Finally, the second accident happened, causing more injuries and fatalities.

- (2) Some devices on the train should be updating. For example, head lamps should be replaced by more effective ones and braking systems should be more capability so that the maximum illumination distance of head lamp is larger than braking distance and then train can be stopped before collision.

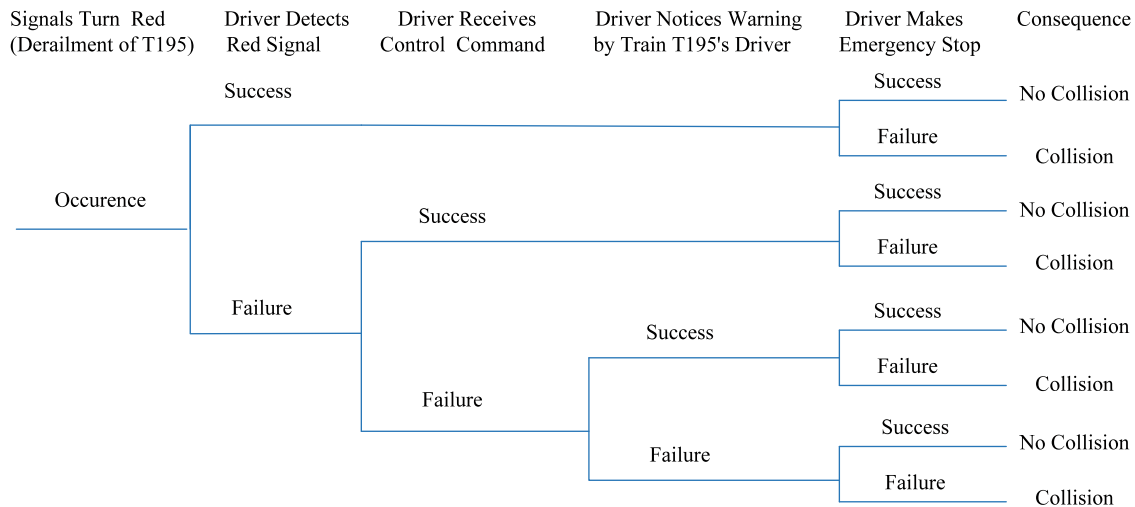
Fig. 10. Event sequences for the collision after the derailment of train T195.

From above analysis, it can be found that the second accident is the spread of the first accident. To quantify the relationships between them, Probabilistic Risk Assessment (PRA) method can be used. This method needs to identify all possible accident event sequences leading to the accident and then take an appropriate measure to estimate the accident sequence. So the most important thing is to find out accident occurrence conditions, whose correctness has a large impact on the validity of analysis results. Usually, the derivation of occurrence conditions depends on the subjective judgment of system analyst and designers, which might cause an error. To obtain an objective accident occurrence conditions, the STAMP-based analysis is useful. From the control structure in Fig. 9, train 5034 was directly affected by its driver and decisions of 5034's driver were influenced by three factors: the signals, the Jinan railway bureau and train T195's driver. To affect the decisions of 5034's driver, the Jinan railway bureau was through sending control commands and T195's driver was by use of warning. So there are totally four factors leading to the second accident after the first accident happened. They are respectively, the signals, the Jinan railway bureau, train T195's driver and train 5034's driver. According to these factors, the relationship between the two accidents can be described by the event tree in the Fig. 10.
